An On-Site Post-Event Survey of the 2022 Mw 6.1 Western Pasaman Sumatera Destructive Earthquake

Abstract. On February 25, 2022 at 08:39:29 Local Time an unexpected earthquake with a magnitude of 6.1 Mw struck the Western part of Sumatera, onshore, and located on the blind fault. It is very likely that the earthquake was from Angkola Fault, but there is still a possibility that there are still other active faults in this area that have not been mapped yet. The areas that were affected by the earthquake are Pasaman, Western Pasaman, Limapuluh Kota, Padang Pariaman and Agam regencies. The focal mechanism from BMKG show that the dominant mechanism of this earthquake was the right lateral (dextral) strike movement. The worst devastation was in Western Pasaman and the damage from this earthquake was wide spread. An estimated 6627 houses have been destroyed and 70 mosques were damaged, 41 offices were devastated, 208 schools and educational institutions, 25 medical infrastructures, and 5 bridges were damaged. An on-site post-event survey was carried out to investigate the effects. We conduct mapping ground ruptures and cracking in an effort to find surface expression of fault rupture. Ri

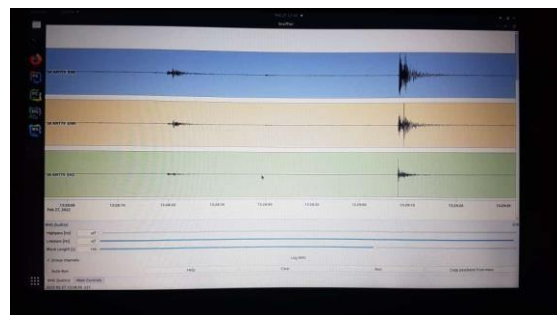
Fig.7. Aftershock recorded on the on-site detection using Seismograph at Kajai Village
